Post-Flight Analysis of Selected Fluorocarbon and Other Thin Film Polymer Specimens flown on MISSE-5

Kim De Groh NASA GRC

Miria Finckenor NASA MSFC

NSMMS June, 2007

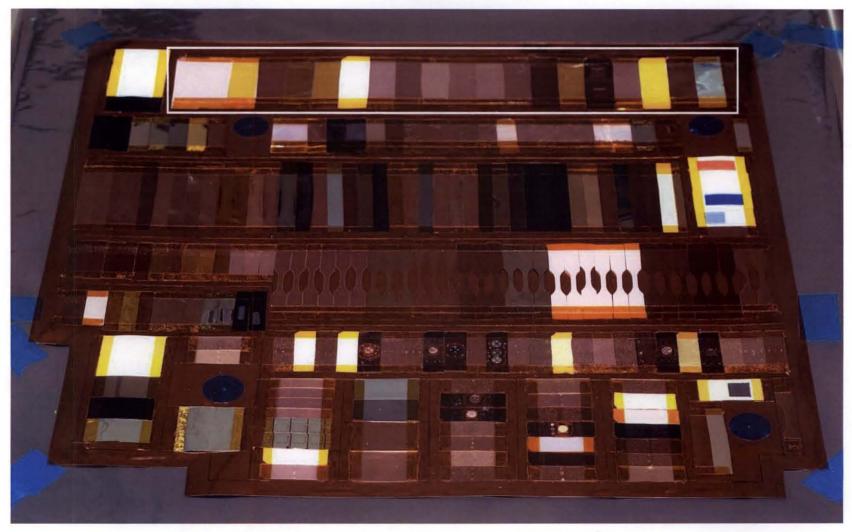
MISSE-5 Thermal Blanket Materials Experiment

Team Cooperative samples (20) outlined in white

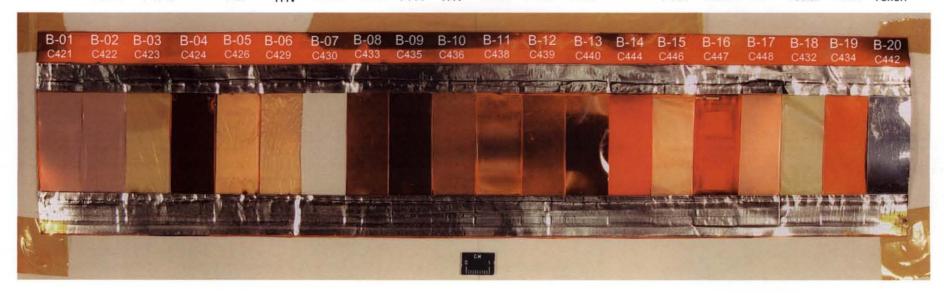
MISSE 5 Team Cooperative Samples

0.3 mil 0.3 mil 0.3 mil pieces 0.1 mil 0.3 mil 0.3 mil Teflon Kapton Kapton Kapton Kapton Kapton Kapton Kapton AF Kapton over over over over over Agover PTFE PTFE Halar PVDF 1600 Witness PVDF PTFE FEP **FEP** Tedlar Tefzel PFA THV Matrix PP Tedlar Aclar Teflon THV

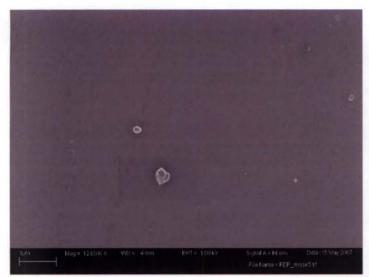
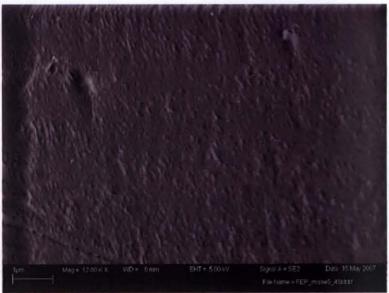
Post-Flight SEM Images of FEP Teflon

Salt crystal
